# Drewton Beck Natural Flood Management Work, 2024

1.1. This report describes Natural Flood Management (NFM) work work carried out on a section of Drewton Beck, east of North Cave, (below) during 6-8 March 2024.

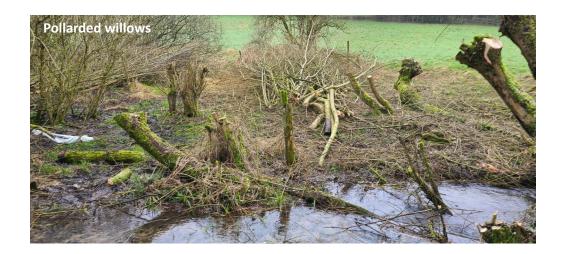
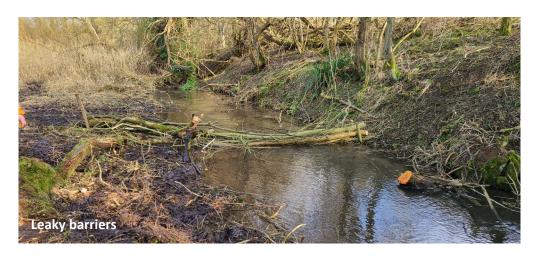
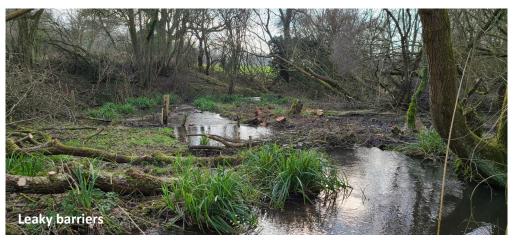
4.2. On closer inspection along the beck, a number of areas have been sky-lighted, principally by pollarding or coppicing of the substantial amount of willow along the valley floor. This has been done in a smaller number of longer sections of around 20m in length, resulting in sky lighting of perhaps 20-30% of this length of the beck.

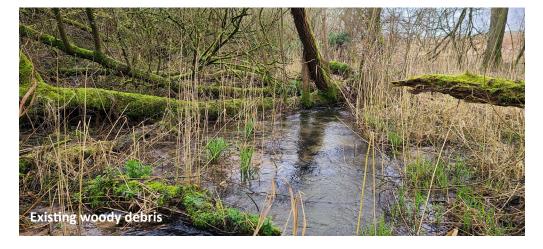
4.5. As noted in previous correspondence, it was found that the beck already had many instances of natural woody debris dams, the beck sometimes finding its way completely under and around willow boughs across its path.

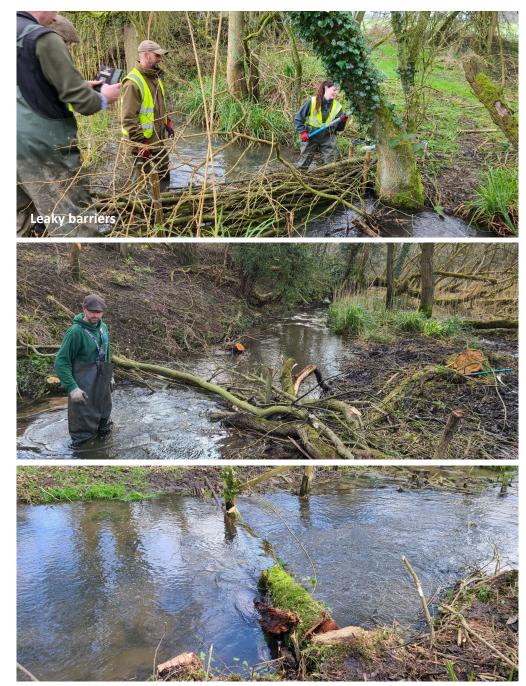
4.6. New leaky barriers have been created, mostly of lighterweight branches, pinned on either bank to prevent mobility. It is anticipated that these will trap an amount of debris and leaves flowing down the beck, resulting in slightly more substantial barriers which will influence currents and create different depths and speeds of water, to provide more varied habitat for fish spawning and fry.

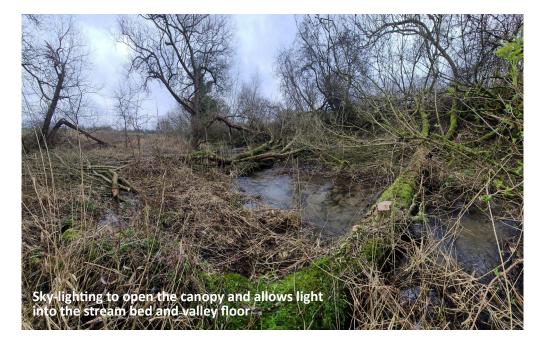
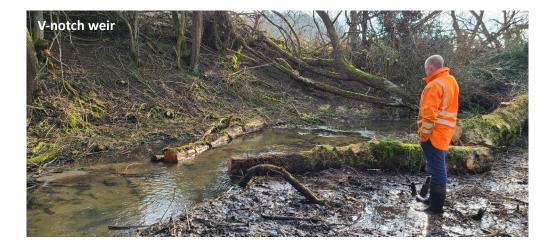
4.9. Overall, due to the extent of natural willow growth across the beck, the EYRT team has a high confidence that there would be no downstream mobility of the introduced material, as anything displaced would be caught by the existing trees and vegetation cover. At the same time, the nature of the valley in this section is that it has a steep bank to the south side (ERYC Estate) and flatter, more open floodplain to the north side (Hotham Estate), none of which is in cultivation, and which has been the subject of conservation (through being fenced off from adjacent pasture) to encourage lowland fen habitat. Should any minor displacement of the beck in this area occur as a result of the leaky barriers, this will simply increase the variation of the habitat and favour the fen characteristics. This is a part of the valley floor variation and roughening, referred to in the project objectives.

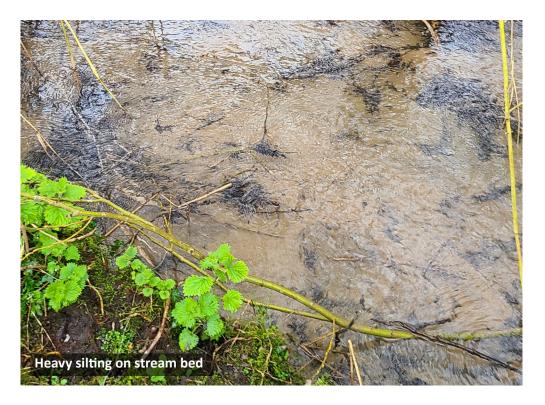
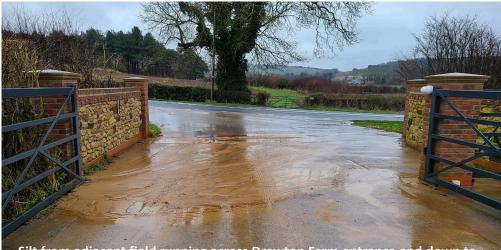
- 5.2. The project ecologist noted that the beck had a high level of silt within it, which would appear to be silt from arable fields upstream for example, large amounts of field run-off silt was noted at the highway entrance to Drewton Farm, which inevitably finds its way down to the beck. This silt clogs the beck and substantially reduces the amount of open gravel (the natural condition of a chalk stream bed). The gravel is key to providing habitat for invertebrates as well as spawning areas for fish. It would be worth considering ways to reduce this run-off, both from a field health standpoint, (it is valuable topsoil that belongs in the fields) and also to prevent the beck becoming overly clogged and affected by pollutants from the soil.

Silt from adjacent field running across Drewton Farm entrance and down to Drewton Beck

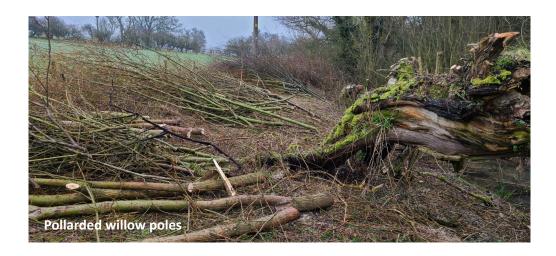
6.1. As noted, there is a now a useful amount of coppiced material in several locations along the beck. This can be allowed to simply lie as dead wood, providing improved nesting and roosting opportunities for native and game birds; some of it could be used to create new leaky barriers within this section of the valley; and some could be extracted to be used to make leaky barriers upstream, or potentially downstream, in future phases of work to the valley yet to be agreed.
